## **THE CAUSES OF LANDSLIDES ON THE ROAD PRISTINA-GJILAN NEAR THE VILLAGE OF MRAMOR<sup>1</sup>**

In order to stabilize the landslide located on the state road N-25/2 near the town of Mramor (Badovce Lake) in the Republic of Kosovo, the following measures were taken: Based on the description of the geotechnical study, study of the area around, the place where the landslide occurred on the right side of the National Road N25.2 directions: Pristina-Gjilan.

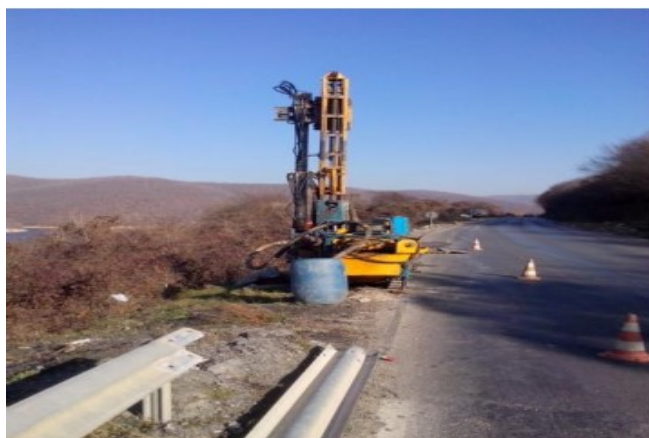
**Fig. 1 - Drilling details on site location [3]**

The field research program carried out 6 (six) drilling studies with a depth of 3.00 to 13.00 m. In the station plan (Appendix 1, Figure 1A), ranking of the drilling study in relation to the station plan is shown.

The coordinates are shown in the KOSOVAREF project. Labels on drilling position surveys are given in Table 1. [3]

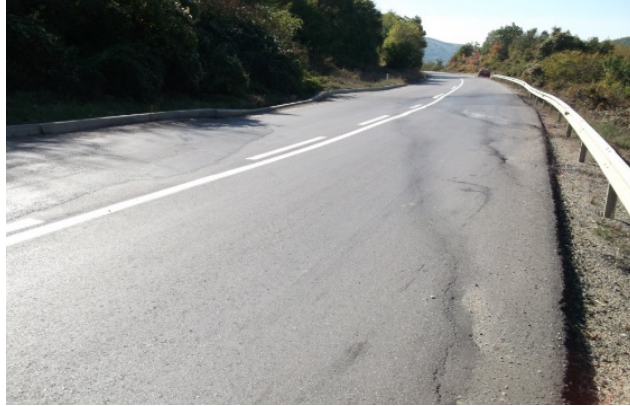
Fig. 2 Skating slot on the regional road Pristina - Gjilan [4]

For a long time since the activation of this landslide since 1974 and the unsuccessful rebuilding of 1983, no one has dealt with this topic, and never one of the competent authorities was interested in paving every year asphalt to handle on both sides of the road as which is shown in Fig. 1, so the measurements of this landslide were made in November 2011.

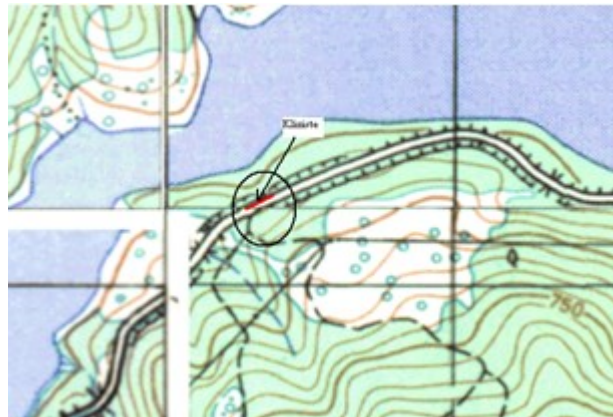
Fig. 3 Slip position R = 1: 4000 [5]
